## PARARESCUE MISSION REPORT:

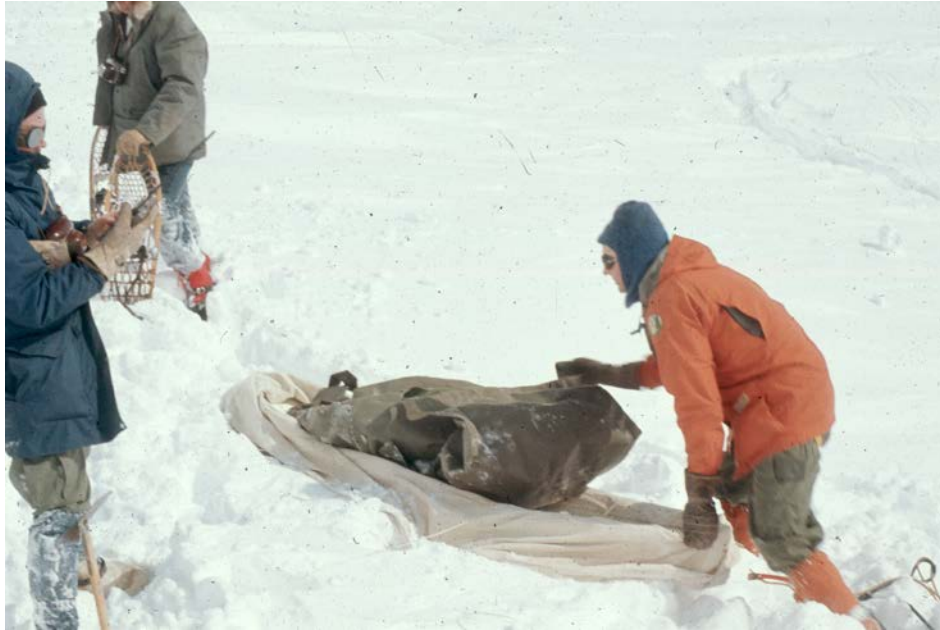
At one point of the climb a team member was pushing a spike of the axe into the snow to test snow depth and consistency when the shaft broke. No sporadic or excessive pressure was being exercised during this test.
