USAF ACCIDENT/INCIDENT REPORT

1. DATE OF OCCURRENCE (Year, month and day) 1964, June 29	2. VEHICLE(S)/MATERIAL INVOLVED <small>(TAG & Serial No., if applicable)</small> HC-97G, SN 522773 HC-54D, SN 4272590	3. FOR GROUND ACCIDENTS ONLY <small>(Base Code and Report Form No.)</small> 1150 AGT
--	--	--

SUMMARY

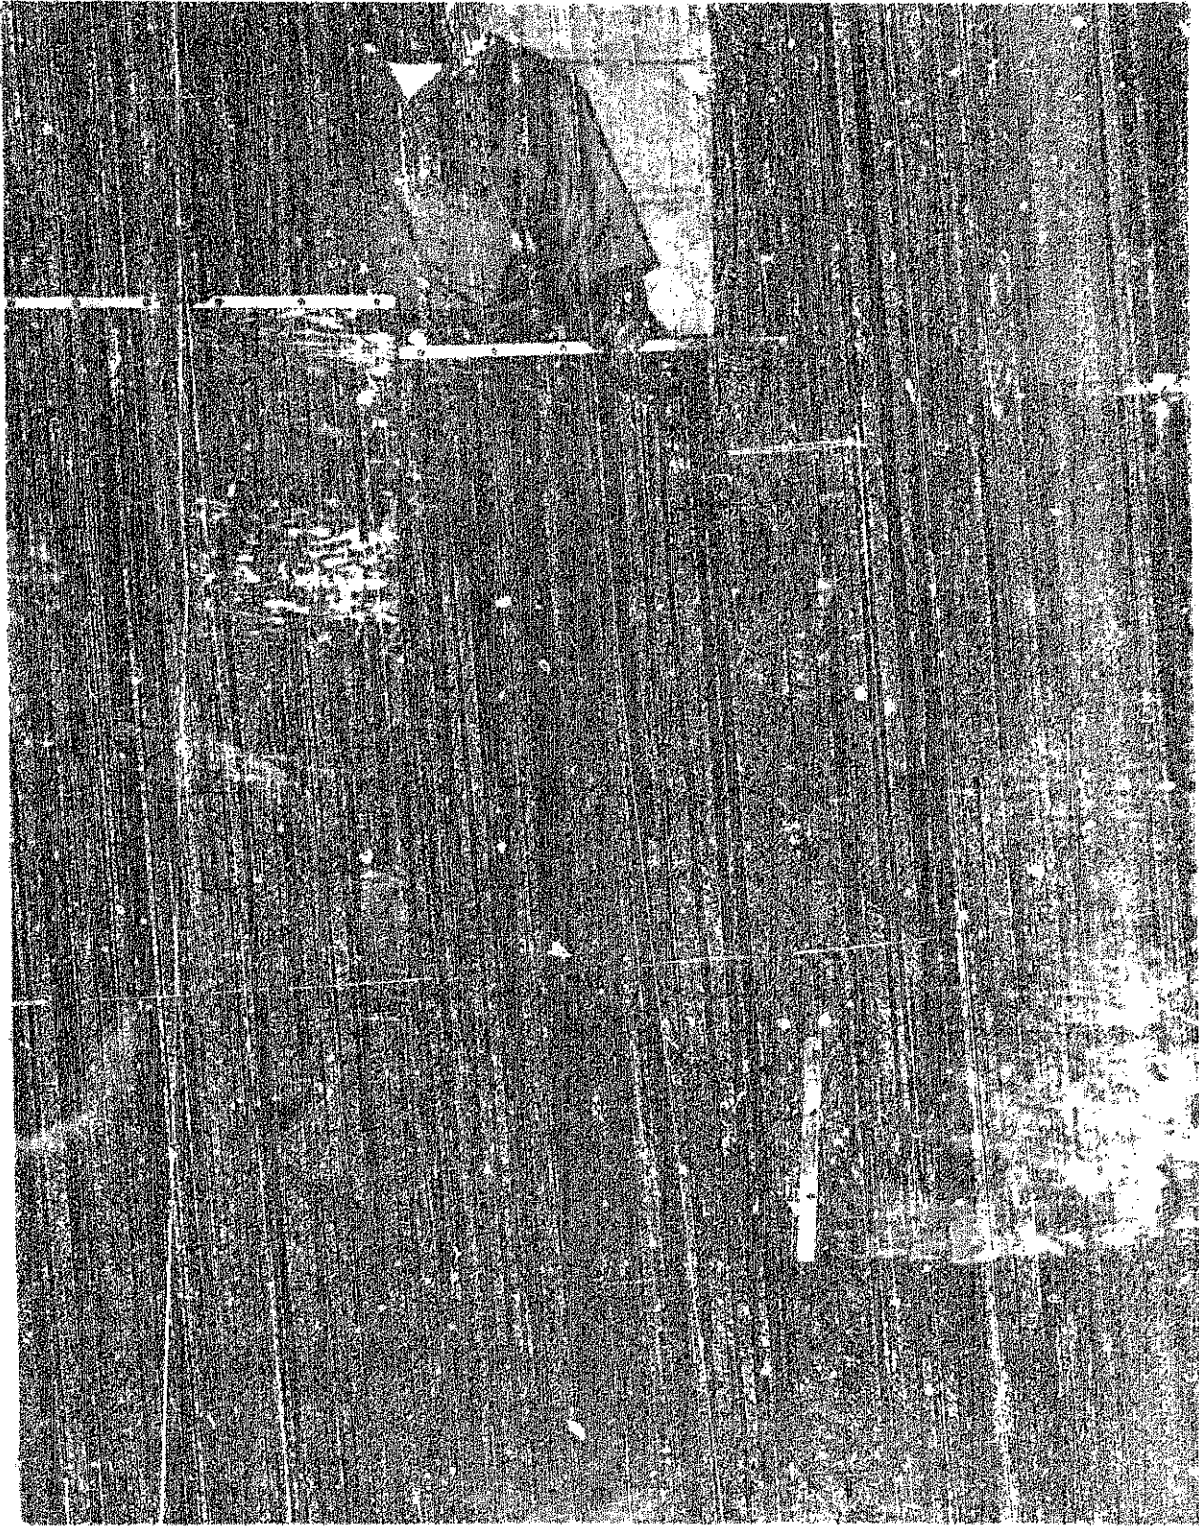
#1 - Underside of shelving in Rescue equipment case HC-5A indicating no fire damage.

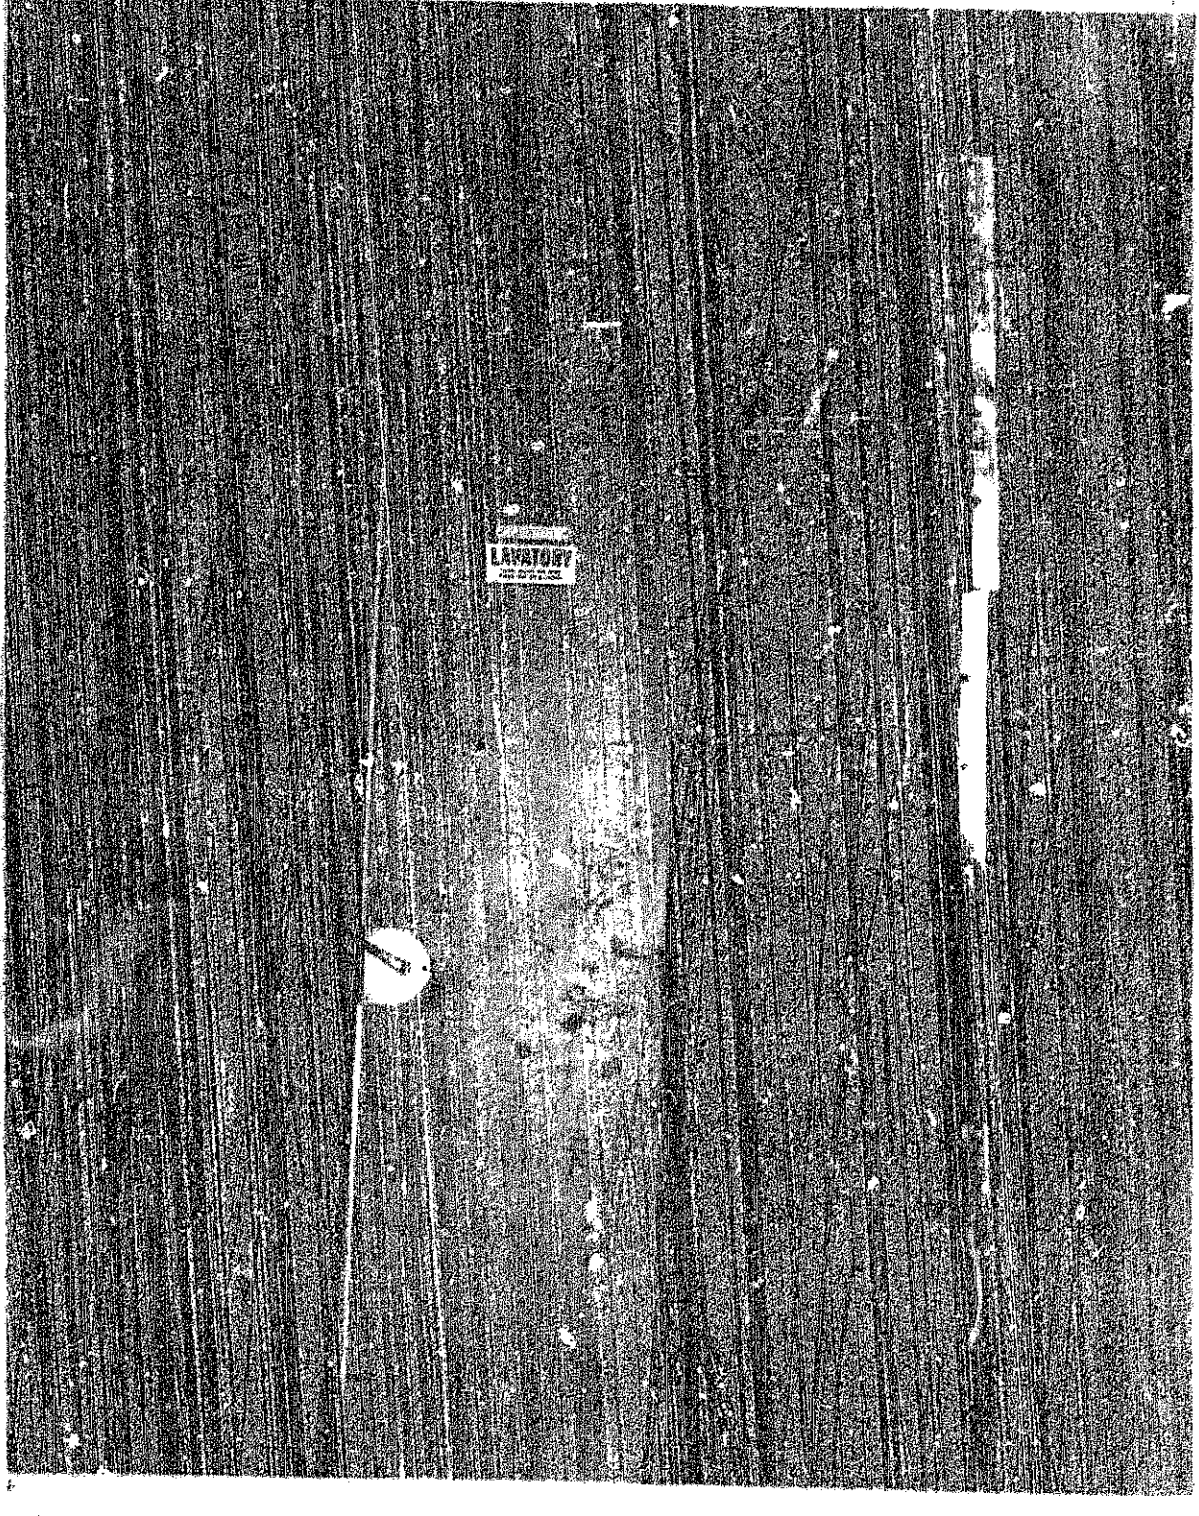
#2 - Plywood sections APT latrine SC-54. Note absence of fire damage.
