FROM: Det 7, 38th ARRS APO 96337

11 Oct 1966

Subject: Mission Narrative Report 1-3-71

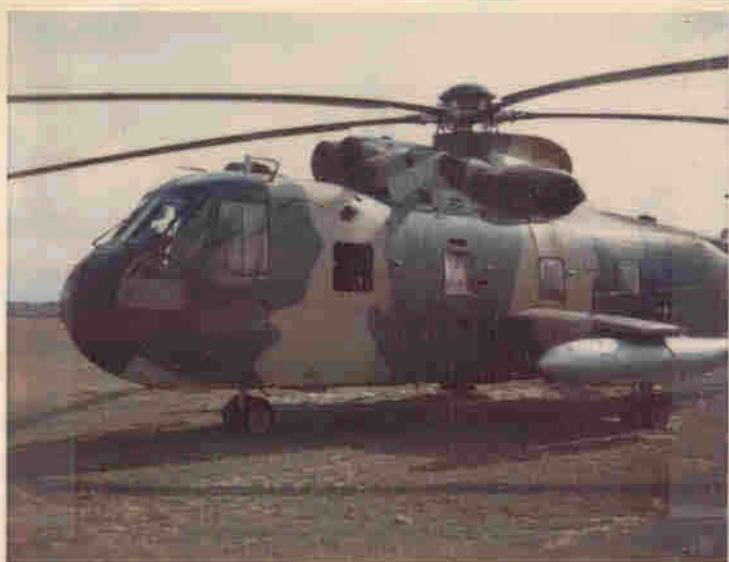
Unsuccessful rescue attempt to rescue Redbird 02,  
Navigator B-57 north of DMZ. 6 October 1966.

Both aircraft sustained multiple hits by ground fire.  
Above picture of J.G. 18 shows 50 cal. damage on left engine.
