## 1953 Taku Glacier Ice Field Research Project

Taku Glacier is near Juneau, Alaska. 10<sup>th</sup> Air Rescue provided support to American Geographical Society for their Juneau Ice Field Research Project.

### 2. The Incident on Taku Glacier

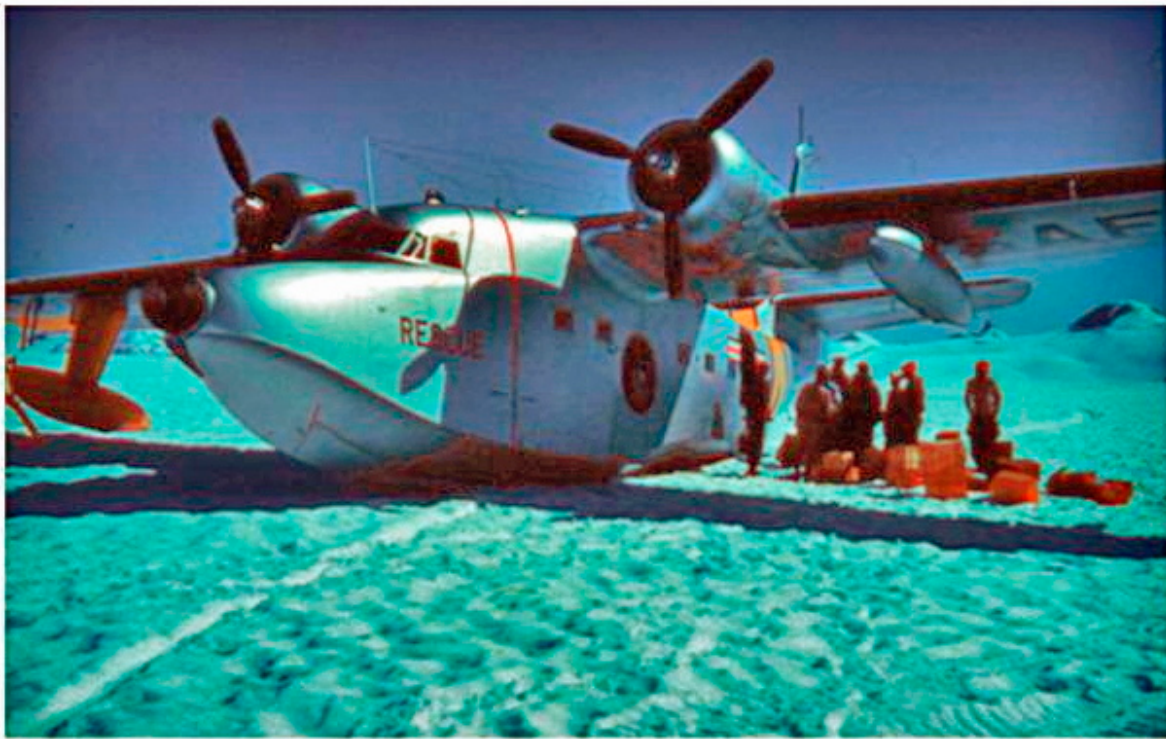
Figure 6.1. Unloading supplies from SA-16 Albatross triphibian on Taku Glacier.

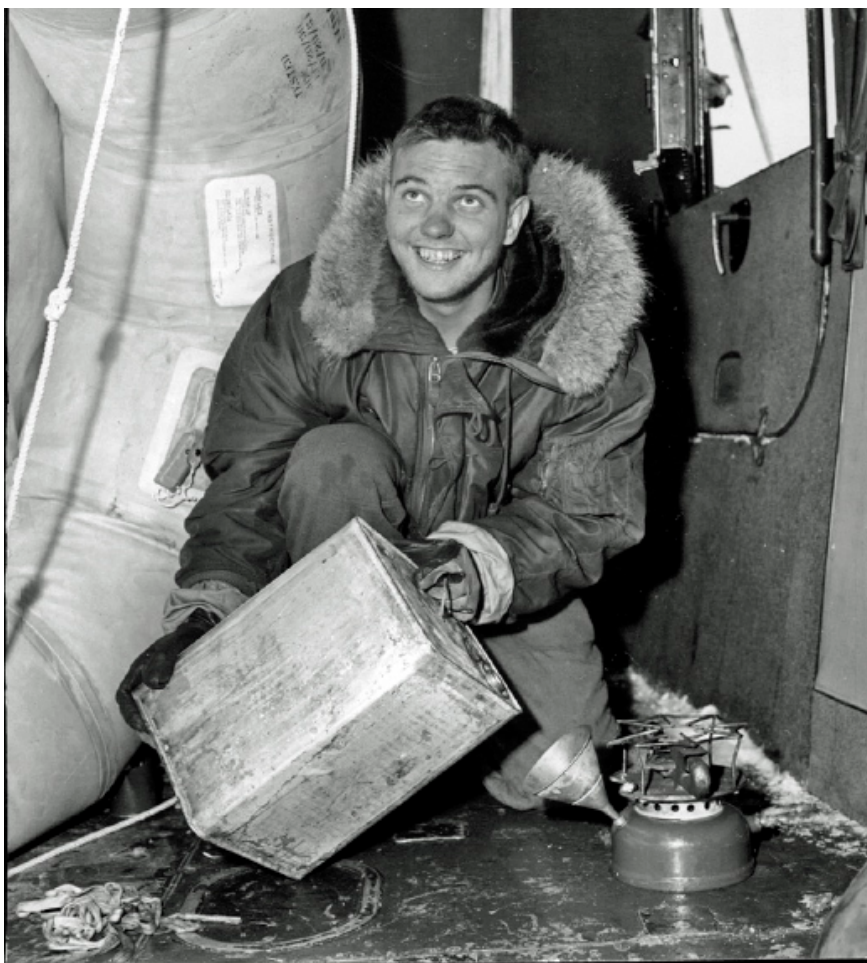
**Normally a no-no, but this is a survival situation aboard the Taky Galcier stuck SA-16 1059, 10th ARSq. AK. 1953**

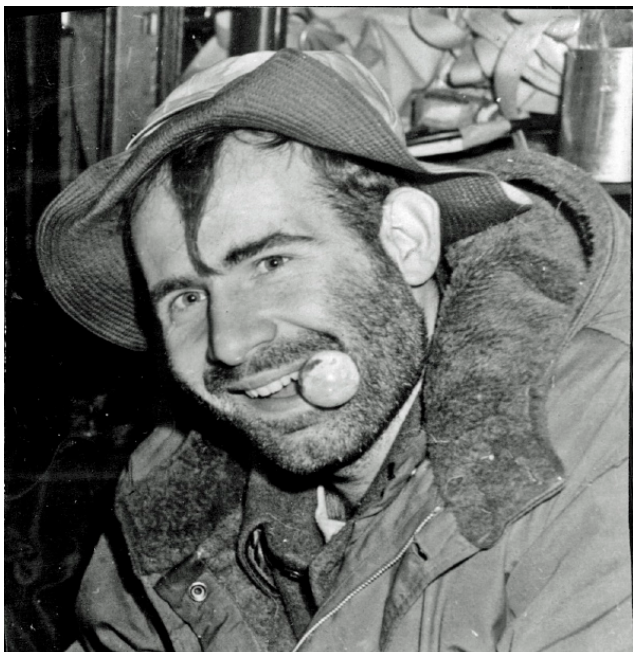
Apparently had spend some time on the Taku  
Glacier (AK-illfated SA-16 1059)  
and was just picked up.
